# Arboricultural Report

## Tree Condition Assessment

Mundy Playing Fields and Poulterbrook

**16th December 2022**

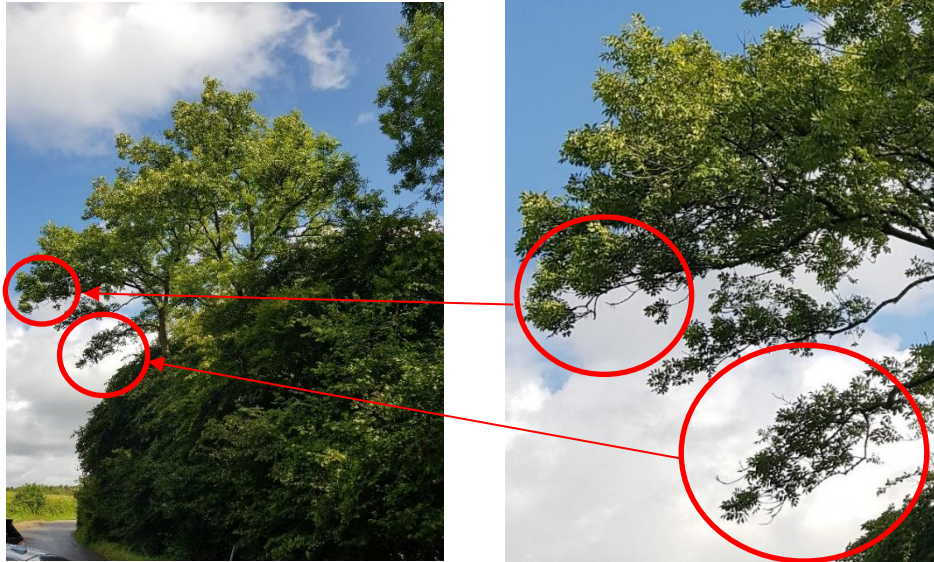
**Stage 1** – This is onset ADD, where bare twigs are present yet the remaining crown appears healthy with no other symptoms yet visible. Approximately 10% of the crown is affected.

**Plate 1: Stage 1 ADD showing bare twigs with no reaction growth present. Often localised with remaining crown healthy.**

**These trees can be generally be monitored and reassessed in 12 months time.**

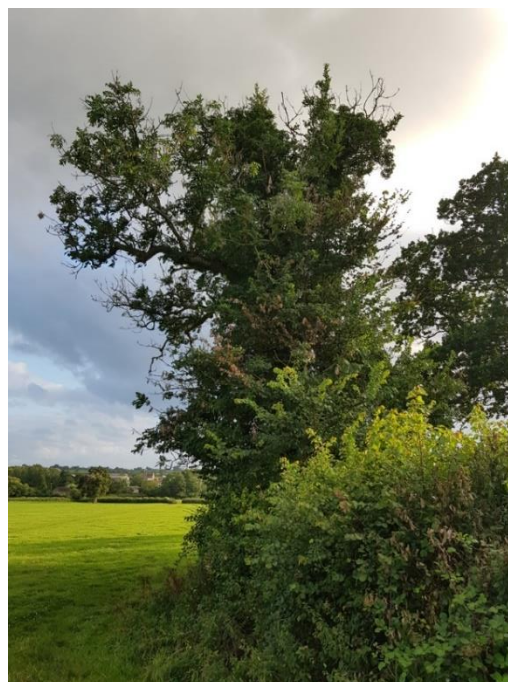
**Stage 2** – The dieback becomes more pronounced and epicormic growth begins to appear below the deadwood on the affected branch. Approximately anything up to 50% of the crown is affected.

**Plate 2: Stage 2 ADD – epicormic growth below areas of dieback**

**Where the target is considered high, tree surgery works should be undertaken in the form of either pruning or removal.**

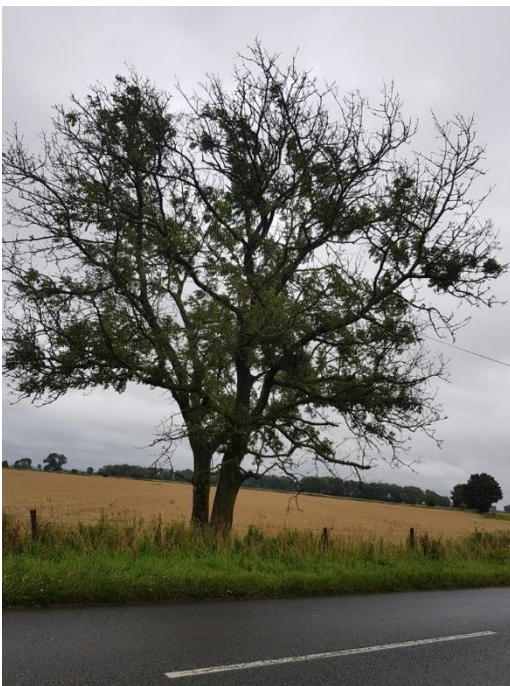
Stage 3 – Epicormic growth has spread throughout the crown and dieback exceeds approximately 50%-75% of the crown is affected.

**Plate 3: Stage 3 – Significant leaf loss. Epicormic growth is the only crown cover**

**Tree removal would normally be required if the target level deems it necessary. A mobile Elevated Work Platform (MEWP) would be needed due to the brittle deadwood preventing access to the tree via rope and harness.**

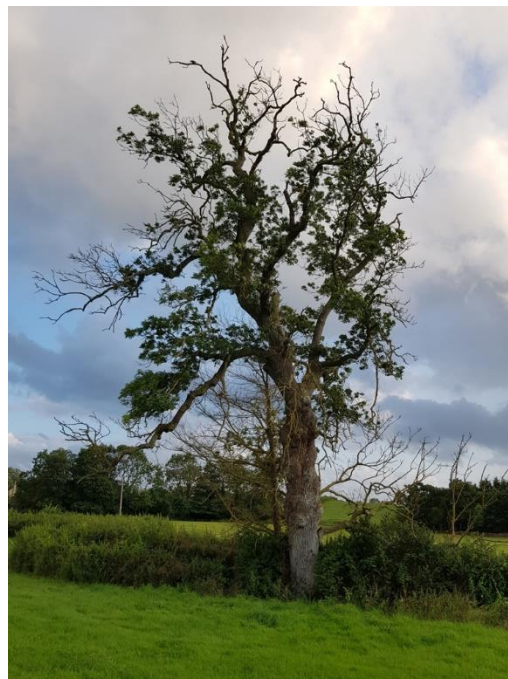
**Plate 4: Stage 3 – Tree is too structurally compromised to access with rope and harness.**
